Pit 5 Powerhouse

US SPEC Products: MP Grout

Contractor: Global Diving and Salvage, Inc.

Engineering Group: PG&E

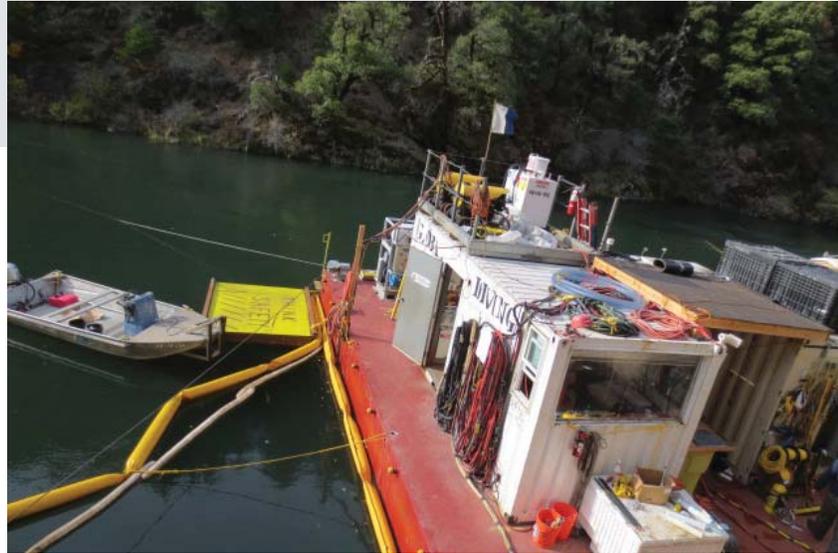
The original concrete bullnose had deteriorated over the last 68 years and needed to be rehabilitated. The powerhouse wall and floors had been beaten up over the years by up to 24” and 500 pound river rock tumbling in the refuse channel. One inch thick steel plates were added as cladding to the powerhouse to protect it from rock damage during generations and heavy runoff. The steel plates were also used as forms to contain the grout which was pumped underwater into the annular spaces.

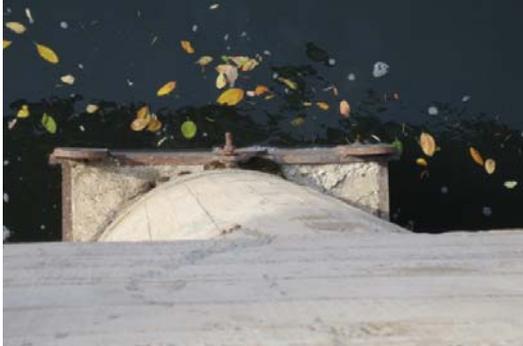
The steel plates were also used as forms to contain the grout which was pumped underwater into the annular spaces. New anchor bolts were imbedded in the original concrete to support the new forms and encapsulate the anchors preventing corrosion. River gates were installed to dewater interior spaces which needed more precise welding. Once the exterior of the facility was finished, Global Diving dewatered the unit and performed additional welding in the dry space. In the dry space, MP Grout was placed in the annular spaces after welding was complete.

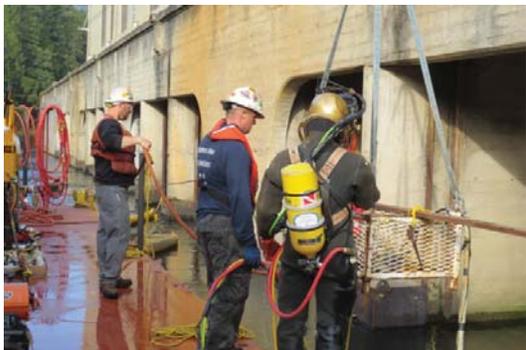
The grout was placed in the 36 foot column through a 1” hose in 12 foot lifts. Due to permitting issues in this highly environmentally sensitive area, no grout entrained water was allowed to re-enter the river. During grouting operations Global Diving used a 1-1/4 inch return hose to catch all displaced water and overflow grout.
